**National Highway
Traffic Safety
Administration**

Case Vehicle (A): 1998 Lincoln
 Type: Continental, 4-door sedan
 Driver: 66-year-old female
 CDC: 12-FCEN-3

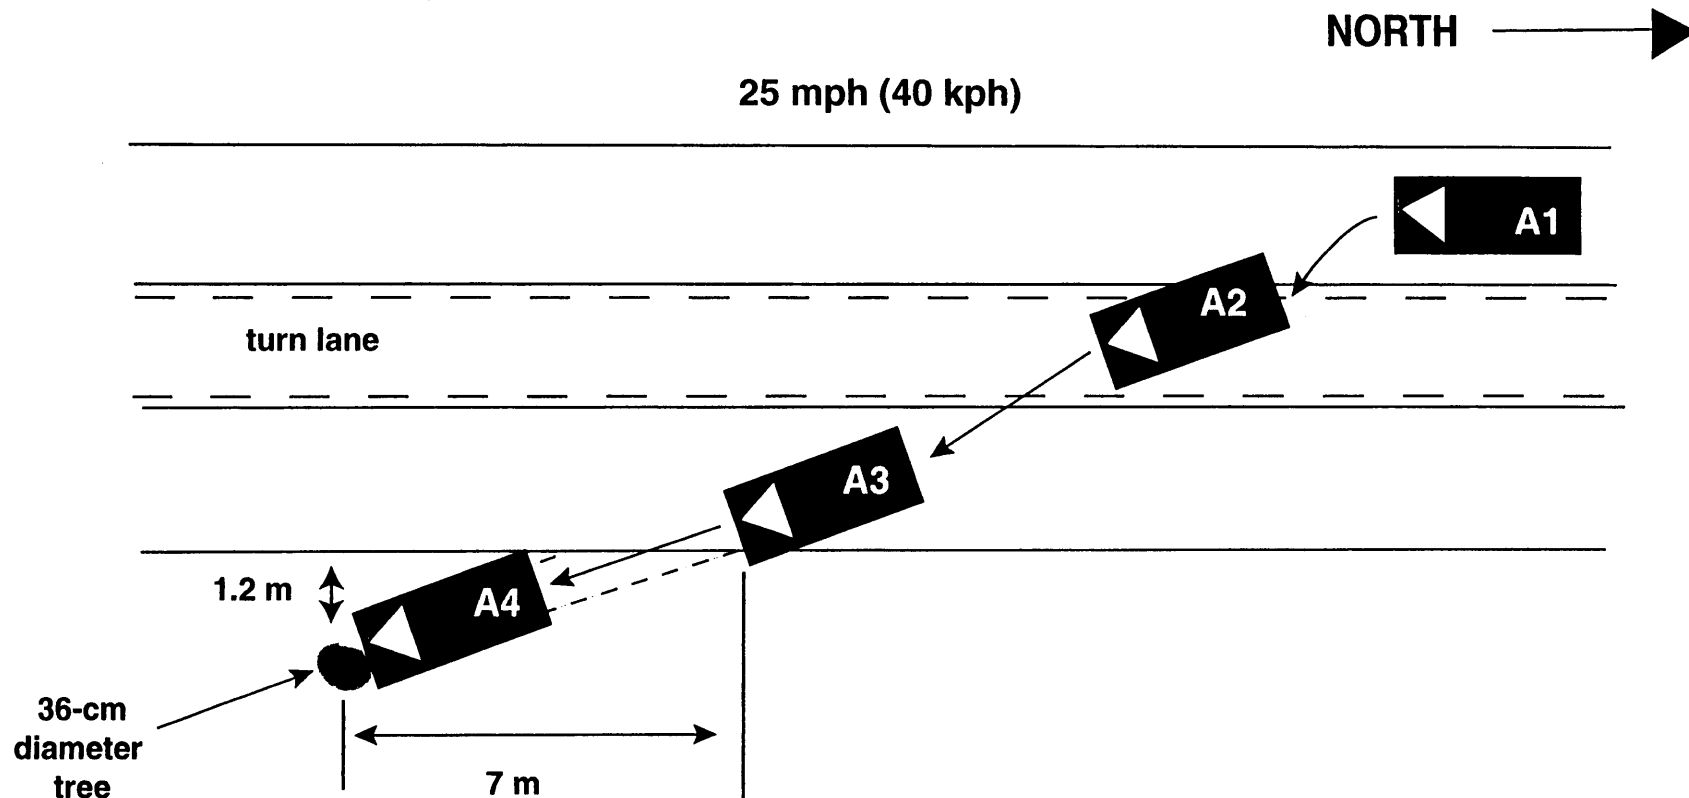
ACCIDENT SCHEMATIC

ACCIDENT DESCRIPTION: CASE VEHICLE (A) WAS TRAVELING
SOUTH AT AN UNKNOWN SPEED IN THE SOUTHBOUND
LANE IN A RESIDENTIAL AREA. THE DRIVER FELL
ASLEEP AND THE VEHICLE CROSSED THE CENTER TURN LANE AND NORTHBOUND
LANE. TIRE MARKS INDICATE THE VEHICLE LEFT THE EAST EDGE OF THE ROAD
AND TRAVELED 7 METERS BEFORE STRIKING A 36-CM DIAMETER TREE WITH
ITS FRONT END.

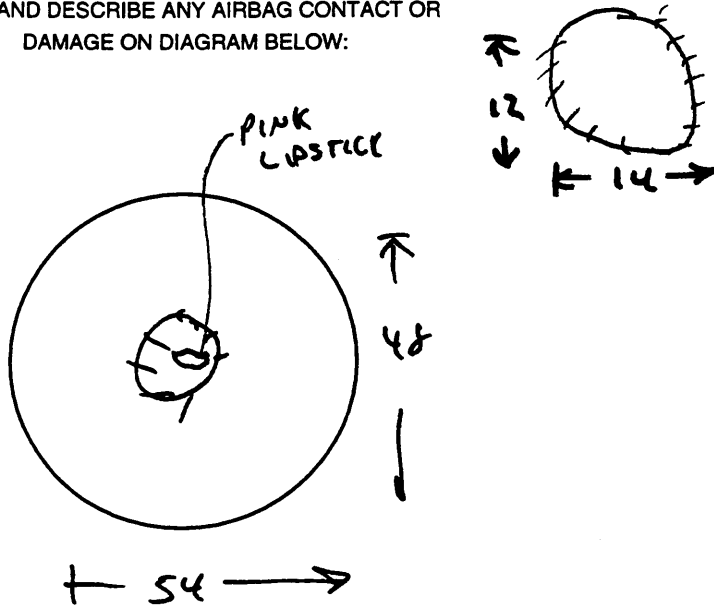
NO
VENTS
